RISK FACTORS CAUSED BY MINING ACTIVITIES IN BAIA MARE

Abstract. - risk factors caused by mining activities in Baia Mare. In order to prevent major unbalances in the geographical area, as a consequence of mining activities, to avoid and reduce the consequence of heavy metal pollution, we identified and analyzed the main areas and locations affected. Also, we will present the conclusions that we reached and the measures that need to be taken.

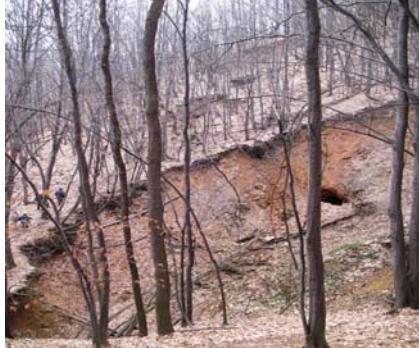
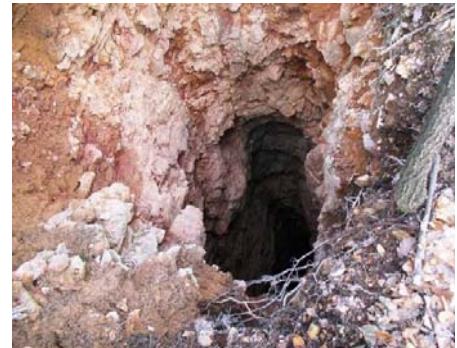
Underground holes which reach the surface. The several such holes identified pose great falling danger for people and animals and represent old ventilation raises, exploiting units, surface wells (older or newer), presenting an urgent need to be appropriately organized (warning signs, fencing). For example, on the right slope of the Antoca valley, belonging to the Sofia (Săsar) mining perimeter, one can find a caving-in with a 30 m diameter, the raise well having a

depth of 50 m, while the ventilation raise of the lode 3, Alexandru, has a depth of 104 m (figura 1)

Fig. 1 Deep caving-in of the Antoca, left-side ventilation raise of the lode 3 Alexandru

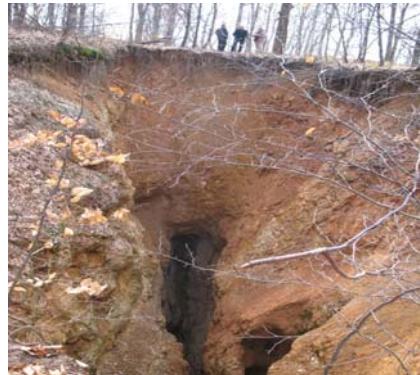
On the same slope, the bank line of lode 10 presents a seriously dangerous caving-in, with a length of 25 m, width of 15 m and depth of 40 m, without having a warning sign or being fenced. (figure 2)

Fig. 2 Caving-in of the lode 10 Sofia bank line Fig. 3 IPEG well- Dealul Crucii

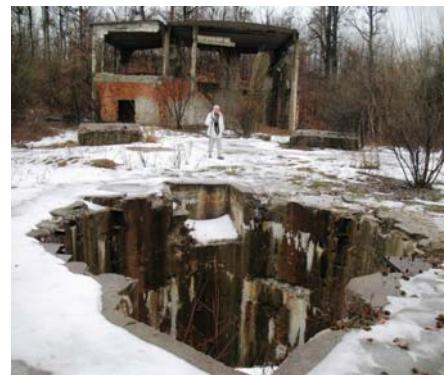
Similarly, the IPEG well on the Dealul Crucii (figure 3), on the right slope of the Vicleanului Valley, is not covered, having a diameter of approximately 5 m and a depth of 60 m; in the caved-in raise of the well, with a depth of 15 m, in 2010 a car has fallen with 2 people in it.

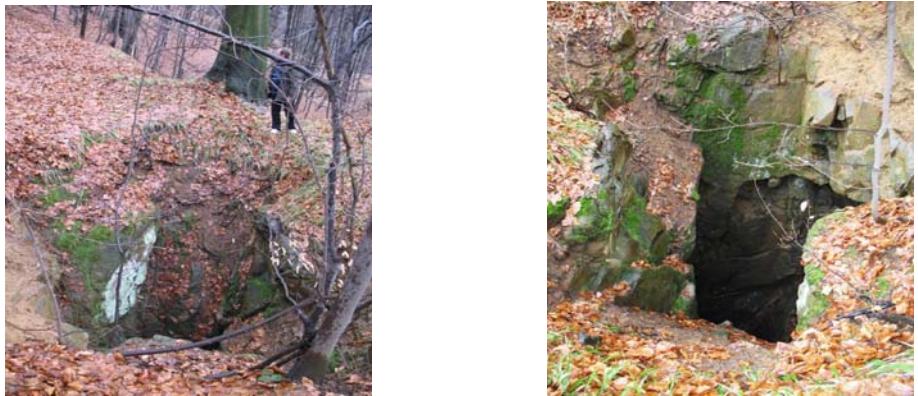
On an old road, within 300 m distance from the IPEG well, the so-called New Well, dating back to the 16th century and manually dug, is uncovered and having a depth of 62 m; similarly to many other caving-ins it is uncovered and unfenced (figure 4)

Fig. 4 The Nou well manually dug in the 16th century, 62 m deep, unprotected today

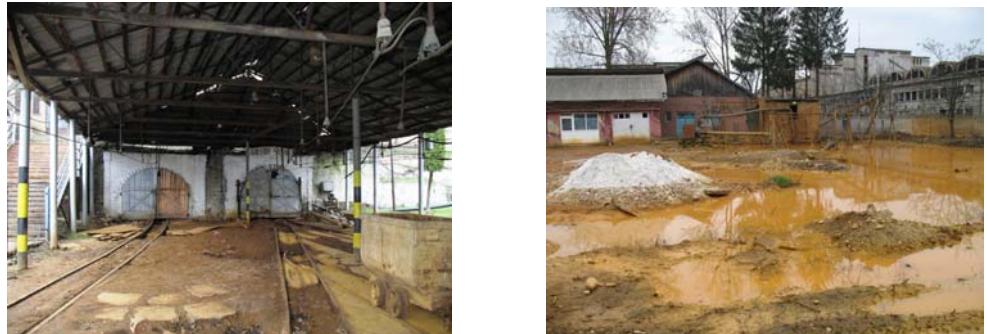
An area of possible extensive caving-ins in the incorporated areas, is situated to the north of the Minerilor-Victor Babeş-Nucului streets, a sector from which 3 main galleries spring; the three were used in the exploitation of minerals situated further north (figure 5) On the several meters long section in which the tree go through brittle sedimentary rocks or through rocks with a possible volume variation, a risk of caving-in is present, caused by the destruction in time of the underground timbering system present there.

Fig. 5 Săsar Gallery-mining premises and the Săsar mining water pumping station

The Săsar Gallery was active until 2006 and is for the most part cemented, also having a parallel conjuncted gallery. There is no short and medium term caving hazard, but in the case of the caving-in of the other two main galleries (Valea Rosie and Dealul Crucii), this gallery becomes the main mining water delivering gallery; the water is evacuated from the gallery through an internal sewer that crosses the enclosure of the Săsar mine then through a sewer in the ditch on Nucului street, in the Victoria Street sewer and into the Sasar river. In the event of heavy rainfall, the sewer cannot sustain the entire debit, which causes the flooding of the old pumping station of the Săsar Processing Plant, and of the Nucului and Victoriei streets as well as several other lots in the area.

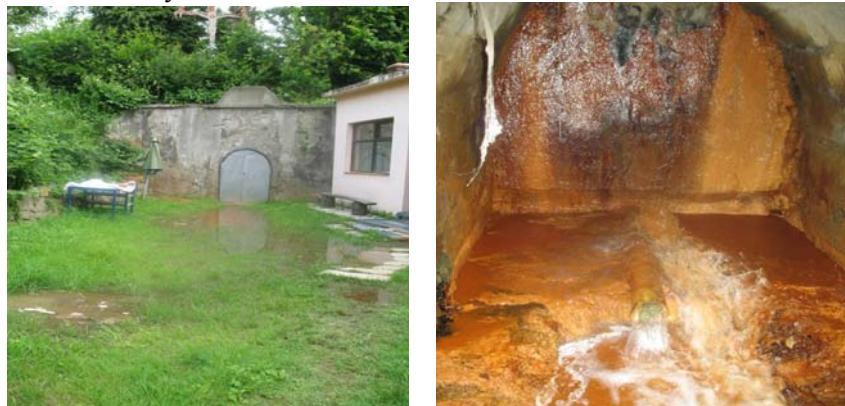
The Valea Roșie Gallery (formerly dubbed Svajczer, then Cuza Voda). The mining premises here was closed at the same time the Săsar quarter construction halted. After the closing of the gallery, in short timeframe, a 1.5 meter mud layer had formed, making the gallery inaccessible as of now. It is situated in the city of Baia Mare, at the corner of Iuliu Maniu and Victor Babes streets (figure 6). A debit of approx. 5 litres/sec comes out of the gallery, and flows into Baia Mare's sewer system. Following a series of rainfalls in the months of May and June 2010 there have been sightings of exfiltered mining waters on a several lots found above the Cuza Voda gallery.

Fig. 6 Cuza Vodă Gallery, Baia Mare, Iuliu Maniu Street

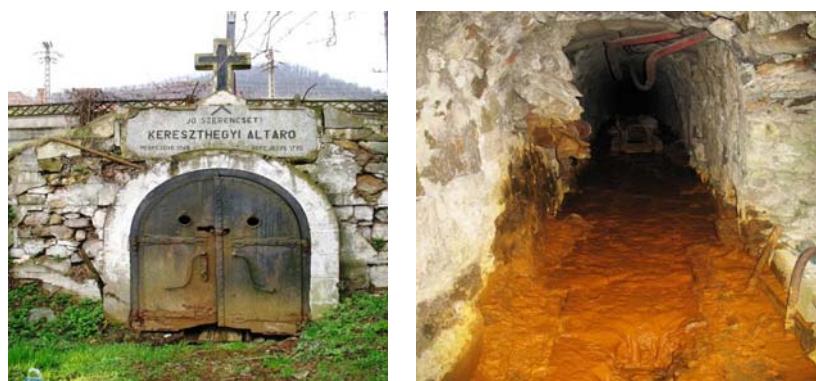
The Dealul Crucii gallery (formerly dubbed Inaltarea Sfintei Cruci, Lobkowitz or 23 August) was dug between 1765-1795 and used as EM Săsar access until 2006 (figure 7). The section that goes through the sedimentary is affected by pressure phenomena, the gallery having sectors that are reinforced with cemented rock masonry.

The cement is degradable, favoring caving-ins. Such a collapse took place in 2008, underlined by a surface collapse cone formed in the backyard of a home.

Fig. 7 Lobkowicz (23 August) gallery, mud-filled

Mining waters from the Lobkowicz gallery flow with a 7l/sec debit into the the Baia Mare sewer system.

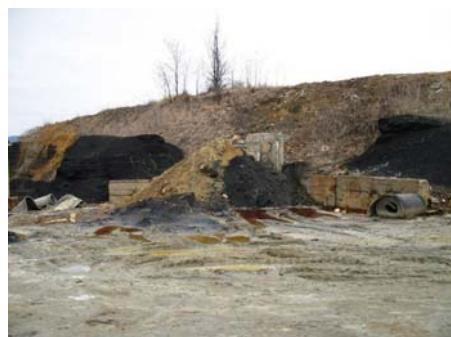
Fig. 8 Entrance of the Herja UP Flotația Centrală gallery

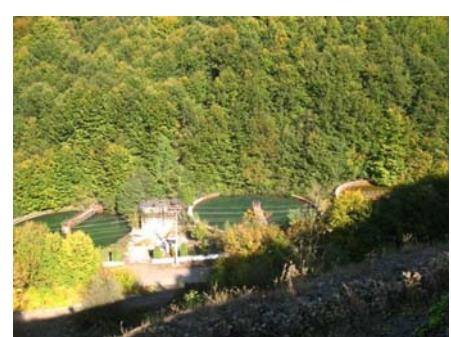
- The Herja Mine (Ioachim gallery). Activity at the Herja mine was stopped in 2006. Infiltration waters at the surface and in the mining holes are accumulated underground and are evacuated by means of well pumping, fromwhere they are gravitationally evacuated on a distance of approx. 1 km to the main premises of the Herja mine (figure 8). The Herja mining waters are directed though an inner sewer to the Herja mining water treatment station where they are neutralised with lime (figure 9).

Fig. 9 Herja mining water treatment station
