LESSONS FROM HISTORICAL DIKE BREACHES IN THE CARPATHIAN-BASIN

L. NAGY

Key-words: flood hazards, lessons, Carpathian-basin

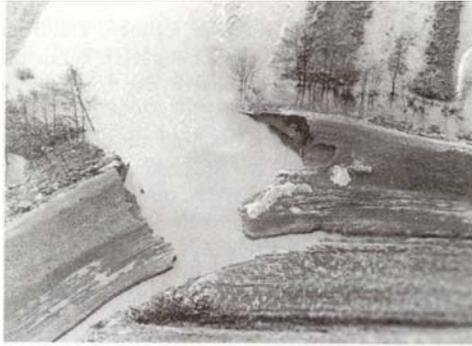
Photo 3. Elba river left bank at Dorctersen in 3. January 1976 (Germany).

The remaining dike stubs are almost always vertical. Their direction is either perpendicular to the longitudinal axis of the dike or the opening narrows towards the protected side at a slight degree of inclination. (Photos 3, 4 and 5)

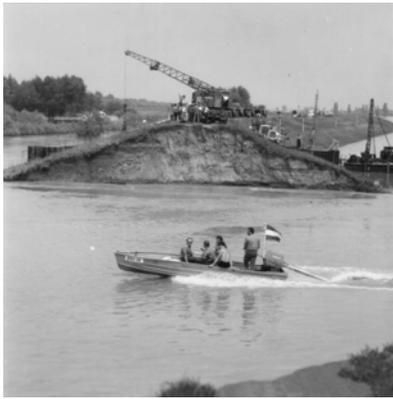
Photo 4. Kettős-Körös flood in 1980
Hosszúfok dike breach (Hungary)

Scour pits would rarely erode backwards to show up on the water side. The Hosszúfok dike failure during the Kettős-Körös flood in 1980 illustrates this phenomenon, which subsequent studies proved to have evolved due to the presence of disperse soil. The scour pit advanced to reach the water side of the dike, which is why the pile-plank barrier constructed during the flood to close the breach had to follow an unusual large curve on the protected side. (Photo 9) Photo 10 of the dike failure on the left bank of the Tisza at Királyháza in the Ukraine in 1998 also shows a scour pit that progressed to reach the water side.
