ASSESSING THE PHYSICAL QUALITY OF THE COȘUȘTEA RIVER USING THE QUALPHY METHOD

G.A.MOROȘANU^{1,2}, G. VERNIERS³, L. ZAHARIA¹

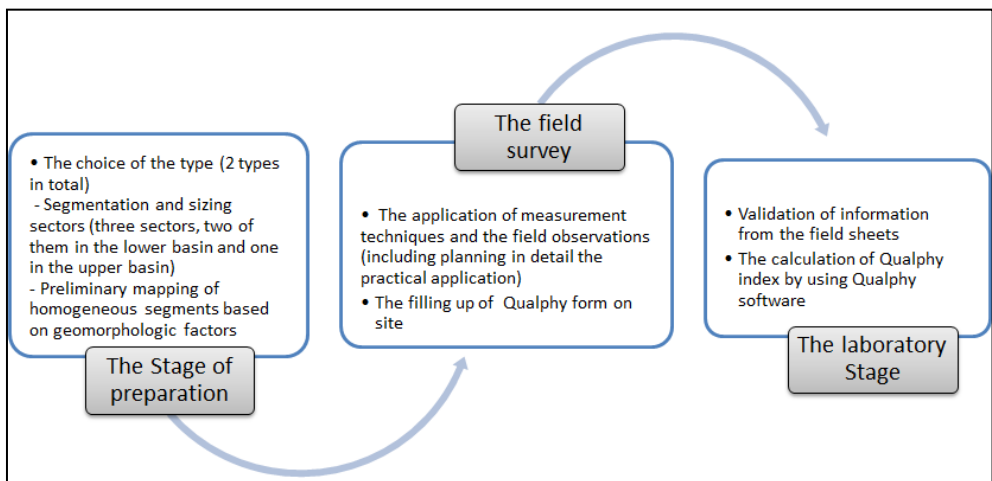
The functioning of the Qualphy method requires to respect a general workflow (Fig. 2) with some specific features for this scientific approach.

Fig. 2. The general workflow of the Qualphy method

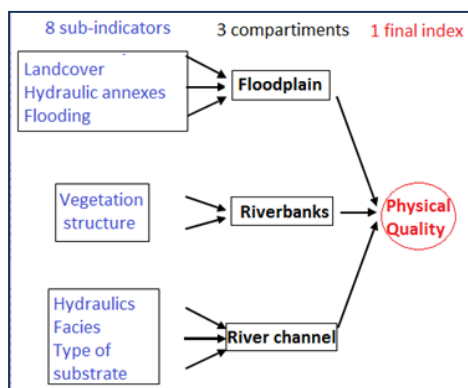
sub-indicators which led to the estimation of the Qualphy indices for each of the three compartments of the river valley, the floodplain, the riverbanks and the riverbed (Fig. 3). Finally, the Global Qualphy Index was calculated, as a weighted average of the typological variables' values calculated for the three compartments of the river valley. Values are ranked and take the form of a tree structure that allows a simple handling of data in the software. Coded data, of a quantitative nature, can be turned by the computer into qualitative values, such as percentages, where lower values reflect detrimental situations. The calculations are made by using the Qualphy.DAM software.

Fig. 3. Calculation scheme of the Qualphy Index

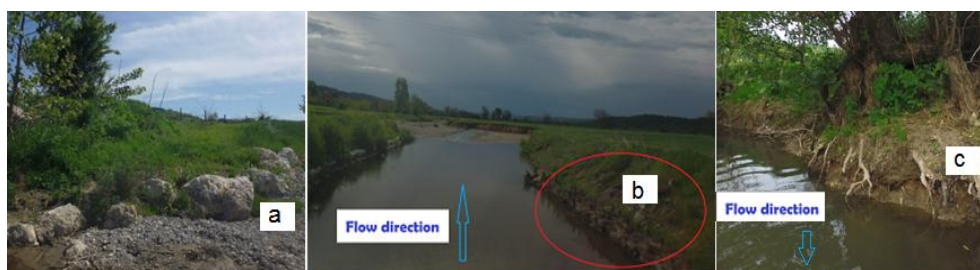
The nature of the riverbanks was assessed through the size of the composing gravel and rocks, whereas for the types of banks, the natural and man-made forms were accounted (Table 6). Some examples of the riverbanks natures from Șișești and Nadanova sectors are illustrated in Fig. 5:

Corcova		Șișești		Nadanova	
	Dominant	Secondary	Dominant	Secondary	Dominant	Secondary
Right Bank	Sand	Clay and vegetation	Vegetation	Stone blocks (Fig. 5.a.), gravel, soil	Clay	Clay and vegetation
Left Bank	Sand	Clay and vegetation	Clay	Vegetation and wood bundles (Fig. 5.b.)	Roots (Fig. 5.c.)	Clay and vegetation

Fig. 5. Nature of the riverbanks: a. Stone blocs on the left bank of the Șișești sector; b. Wood bundles used to consolidate the banks at Șișești; c. Tree roots on the left bank of the Nadanava.

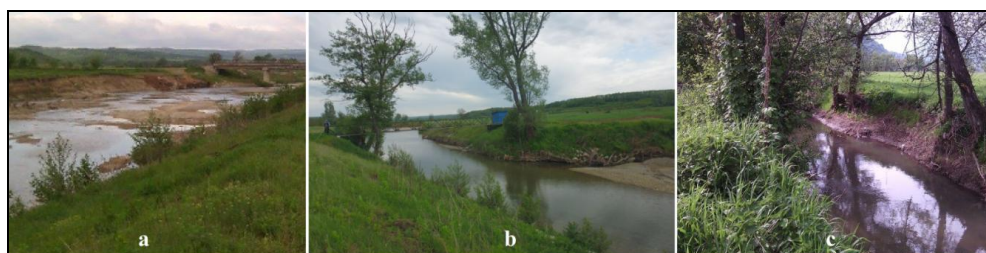
Fig. 7. Vegetation on the riverbanks of the Coșuștea River. a. Corcova; b. Șișești and c. Nadanova sectors.

Corcova	Șișești	Nadanova
Distinctive riverine vegetation	No	Yes, on the left bank No, on the right bank	Yes, well defined (Figure 7.c.)
Location of the vegetation band	-	Left bank – at the front of the bank and beneath it Right bank – only beneath the bank	On the bank's front and beneath it
Significance of the shadow provided by vegetation	10 %	On the left bank – 50% On the right bank – 10%	80 %
State of trees along the river	Suspended (unreachable for plants)	Wooded river vegetation, well maintained or without need for maintenance	Well maintained trees along the river or vegetation that does not require maintenance
Composition of the vegetation	Grassland (Fig. 7.a.)	Bushes on the left bank and no vegetation, or farmland, on the right one (Fig. 7.b.)	Vegetation with three layers (trees and bushes) and, occasionally, grass.
Percentage of illumination of the water's surface	More than 75%	More than 75%	5 – 25%
