MINERAL WATERS AND THERAPEUTIC MUDS FROM HOMOROD BATHS (BRAȘOV). CHARACTERISTICS AND EXPLOITATION

ABSTRACT. Mineral waters and therapeutic muds from Homorod Baths (Brașov). Characteristics and exploitation. The work aims to present some physico-chemical characteristics of mineral waters and muds from Homorod Baths, a succinct history of knowing and capitalizing on these resources and the possibilities for future development. It is based on the synthesis of information from specialized scientific papers (including cartographic documents), archive documents, as well as on the performance of own measurements on physical-chemical parameters (2011-2016) and interviews with locals and local authorities. On the basis of observations and field investigations, there are also presented aspects of the arrangements that existed for the purpose of exploiting the therapeutical factors and the present state of the Homorod Baths.

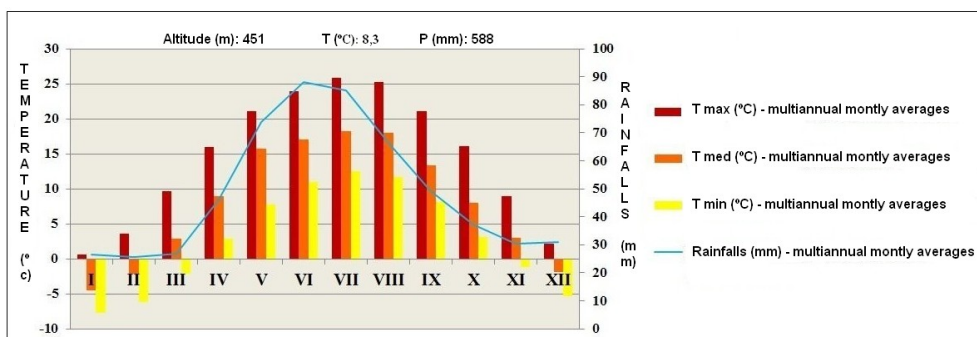
Fig. 3. Variation of air temperatures and rainfalls at Homorod between the years 1961 - 2013 (Data source: Dumitrescu și Bîrsan, 2015)

The specific climate in the Homorod area is the one of intracolinary depression. Between 1961 and 2013, the multiannual average temperature was 8.3°C, the maximum monthly average temperatures exceeding 25°C in the summer months (Figure 3). The average annual sunshine duration was 2042 hours. The average multiannual rainfall was 588 mm/year, and the atmospheric nebulosity was

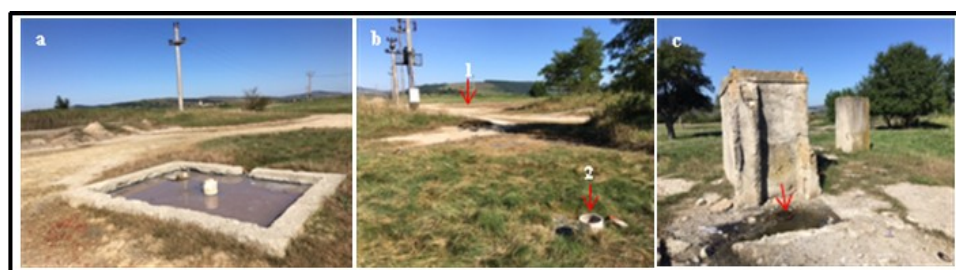
Spring 1 (Figure 5.a) is about 20 m away from the access road and at an altitude of 463 m. The former trapped spring is enclosed in the form of a basin of 3 m long and 2 m wide, which allows the accumulation of mineral water around the drilling. The drilling (tube) is damaged.

Spring 2 (Figure 5.b) is at approx. 6 m away from the access road and at an altitude of 463 m. It is trapped, the drilling (pipe) having the same dimensions as Spring 1, without being fenced.

The spring 3 (Figure 5.c) is located on the right side of the road at a distance of about 30 m from it and at an altitude of 467 m. Until 2016 (January), the drill pipe was covered with a lid metal fixed in screws. Later (July 2016), it disappeared. Probably, it was stolen and taken to scrap iron, the verb "stealing" being the "word of order" at the former Homorod Baths.

Fig. 5. Mineral water sources at Băile Homorod: a - Spring 1; b - Spring 2; c - Spring 3 (Author: Meret, 2011, 2016)

The current state of the three springs is precarious, the drillings are largely destroyed or the water is not recovered, they were collapsed by depositing mineral salts. The other springs mentioned in older sources were probably trapped in the two basins used for bathing (Fig. 6.a, b).

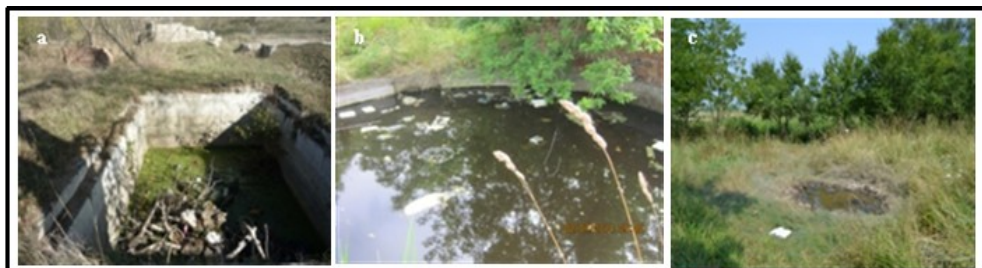
Fig. 6. Other mineral water sources at Băile Homorod: a and b - mineral water trappement basins; c - area with small springs of mineral waters

mineral water were observed. The deposition of "brimstone" at the surface of the soil, determines us to include these small springs in the category of sulfuric waters specific to the Homorod Baths. The old basins, used in summer for external cure, are located a short distance from the access road (2-7 m) and at an altitude of approx. 464 m.

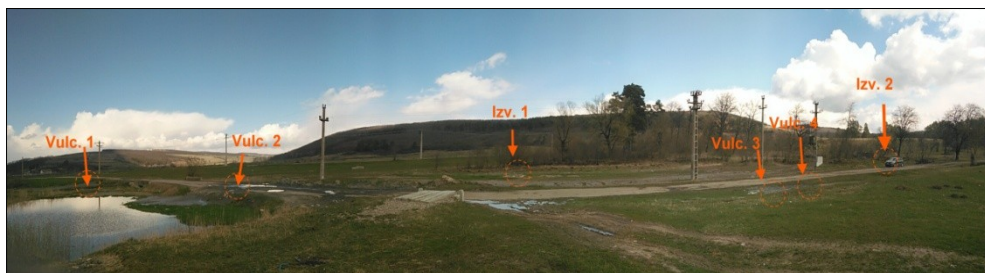
Fig. 7. Location of sulphurous "mini-volcanoes" at Băile Homorod (Author: Meret, 2015)

The eruption sites of the sulphurous "mini-volcans" (Fig.7) also represent "points" of surface appearance for the mineral water.

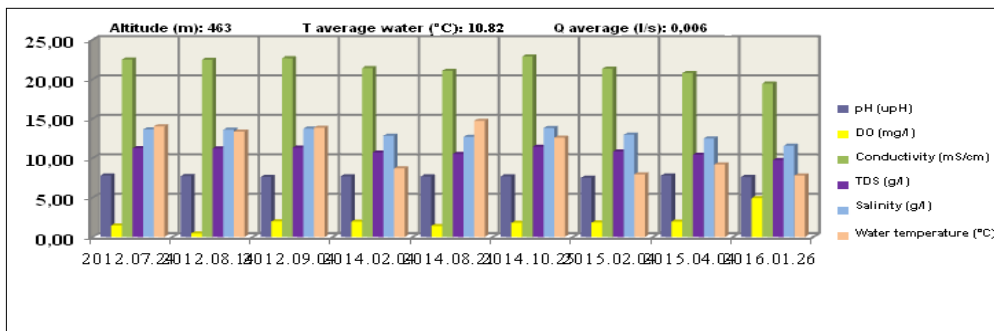
Measurements performed with the Hanna 9828 multiparameter in the period 2012-2016 for Spring 2 indicated a pH with an average value of 7.74 upH, a water conductivity of 21.55 mS/cm, total dissolved salts (TDS) with a mean value of 11,260 g/l and water salinity with an average of 12,99 g/l. The water temperature of the spring varied according to the month / season (the average value being of 10.82°C), which illustrates that the groundwater is not deep. Pascu (1927) mentions that the drilling has a depth of 8 m. Mineral water presents impurities, determined by the deposition of mineral salts on the drill pipe, it has a salty taste and a strong sulfur odor. The flow rate is small and with very small variations in time (0.005 l/s in August, 2014, 0.008 l/s in May, 2015), the average being 0.006 l/s (Figure 8). It may have been unused for many years (since 1975) that the drilling is clogged and therefore the flow measurements have not shown an exact situation.

Fig. 8. Spring 2 from Băile Homorod: physical and chemical parameters variation in the period 2012-2016 (Data source: measurements made by Meret)

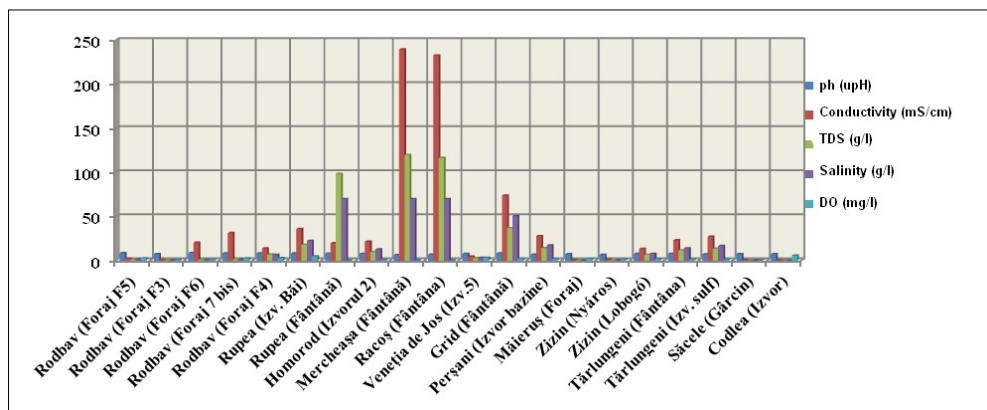
Comparing the physico-chemical parameters of Spring 2, obtained from the measurements performed with the multiparameter Hanna 9828, with the other sources of mineral waters in the county, it is observed that the water of this spring presents a medium mineralization towards the sea (Fig. 9).

Fig. 9. Localities with mineral water sources in Brașov County: variation of the main physico-chemical parameters during the period 2012-2016 (Data source: measurements made by Meret)

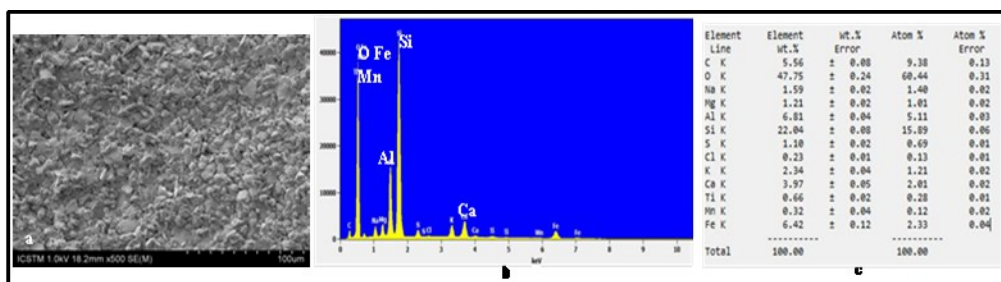
Two samples of sulphurous sludge, one of the eruption sites of a sulphurous mini-volcano, called Homorodul Mare, and a sample of mud accumulation called Homorodul Mic were taken from Homorod Baths. For Homorodul Mare, SEM morphology images indicated that the sample has a granular structure and is compact without any other impurities (leaves, stones, roots, etc.). From the chemical composition point of view, the data obtained by EDS have shown that it is a fairly homogeneous sample, the chemical elements being uniformly distributed. The chemical elements with the highest atomic and mass weights are oxygen, silicon, aluminum, iron, calcium etc. (Fig.10.b, c).

Fig. 10. The mud sample from Homorod Baths, called Homorodul Mare: a - image of SEM morphology; b - graphical representation of the chemical composition of the sample; c - the atomic and mass percentages of the sample (Data source: sample harvested by Meret and analyzed at I.C.S.T.M. of Târgoviște, 2016)

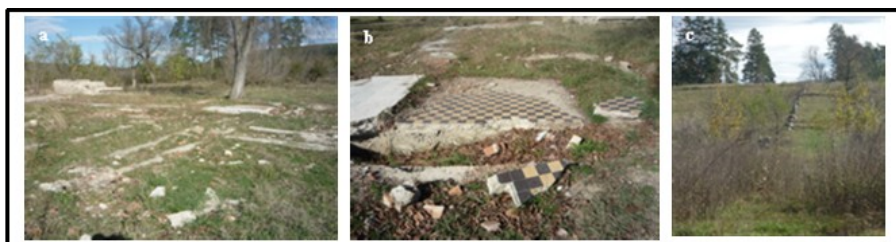
In 2014, remnants of walls, ditches that were the foundations of buildings (Fig. 11a), sandstone debris (Fig. 11b) and mineral springs trappement basins remind of Homorod Baths in 2014. In 2009, 2010, at the entrance there was the indicator on which the Homorod Baths were written, and the fir tree alley ("the promenade alley") was almost intact. But in 2014, tree trunks only witnessed some past "deeds" (Figure 11.c).

Fig. 11. Homorod Baths: a - "traces" of the old spa establishment; b - "image" inside the former establishment; c - "the promenade alley" (Author: Meret, 2014)
