GEOGRAPHIC ANALYSIS OF THE LANDSLIDES OCCURRENCE USING ArcGIS

ABSTRACT. Geographic analysis of the landslides occurrence, Satu Mare county, Romania, using ArcGIS. This multidisciplinary study is aimed at analyzing the natural and anthropic causes that favour the occurrence or reactivation of landslides, which have negative consequences (destruction/serious damages to houses, roads, power supply network, agricultural lands). The research was conducted by experts from the Institute of Geography of the Romanian Academy, Geoproiect Baia Mare. The case study is focused on the Bogdand commune area, located in Satu Mare County.

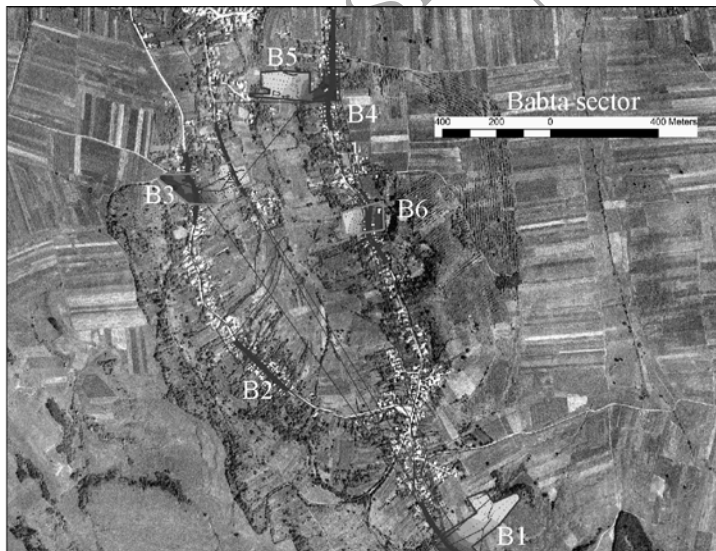
Figure 3. Affected areas by landslides in Babta

In the area of Babta village six regions were identified and studied, Tab. 1. They have particularly unfavourable consequences upon the inhabitants of the village and are caused chiefly by the landslides, Fig. 3.

Sector B1 is located at the limit of the village on the road from Bogdand, a road that has been damaged by the landslides crossing it.

Sector B2 corresponds, together with Sector B3, to a vast landslide, partially reactivated, that in the past damaged many dwelling houses and agricultural lands. It is the sector with the highest landslide potential and risk.

Sectors B4 and B5 correspond to the right slope of the Boierului Stream, including dwelling houses, the village church, streets, the electrical system, the telephone network and farming land.

Sector B6, situated on the same slope includes dwelling houses, streets, the power supply system, the telephone network and farming land.

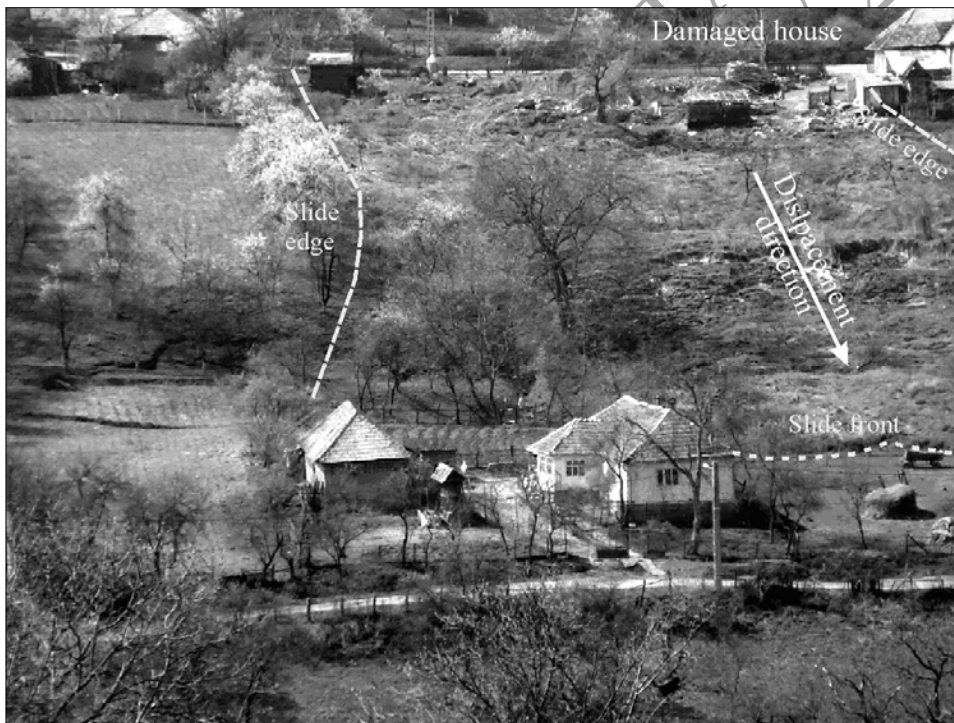
Figure 8. Active landslide with destroyed dwelling houses and land

There are two roads on this sector, as well as farming land and dwelling houses and annexes. When the old slide was reactivated a number of houses were destroyed, others were badly damaged, together with the streets and the farming land, Fig. 8.

The main road, the power supply system and the telephone network seen not to be yet affected by the landslide, but the surrounding houses and annexes were destroyed or can not be used anymore.
