LESSONS FROM HISTORICAL DIKE BREACHES IN THE CARPATHIAN-BASIN

L. NAGY

Key-words: flood hazards, lessons, Carpathian-basin

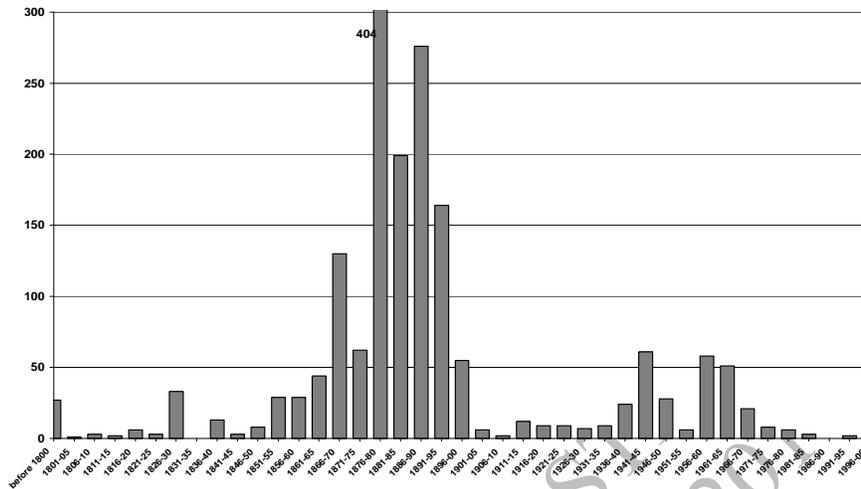
- From the total number of failures for the present territory of Hungary is 1174. The number of failures per five-year periods demonstrates clearly that the large-scale flood control project launched in 1845 was not fully successful up to the turn of the century (Figure 1).

Figure 1. Five years distribution of dike failures

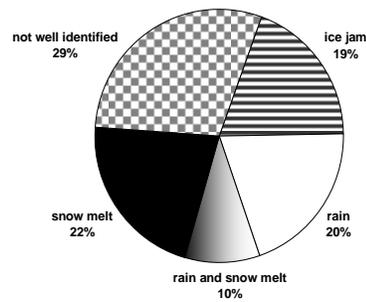
Figure 2. Distribution of flood origin

In the Carpathian-Basin high level water cause three thing, ice jam on the plain section of river Danube, heavy rainfall on the smaller rivers and on the upper sections of larger rivers, and snowmelt in spring. The largest floods become when the snowmelt appear with a heavy rainfall. The distribution of the flood origin can see on the Figure 2 (Nagy, 2000).

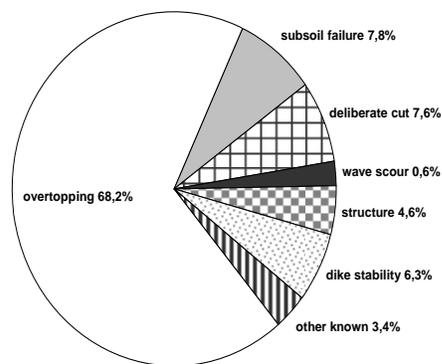
The failure mechanism is known in 525 cases, that is 29% of the total (Nagy, 2000) The distribution of those known is illustrated in Figure 3.

Figure 3. Distribution of failure mechanism

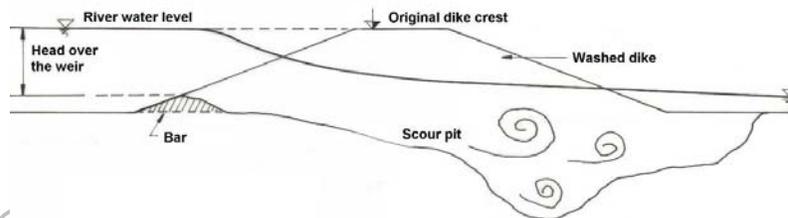
Figure 4. Typical cross section of a dike failure.

A study of dike breach cross sections shows that water washes the full section of the dike away in almost every case. Nevertheless, a small piece of earth normally remains at the water side dike toe, and it reduces the height of overflow as the water falls over it. (Figure 4) This piece of earth is frequently called bar and bar height may even surpass 40 cm. This height reduces the height of overflow and the turbulence building up behind it helps scour pits develop.

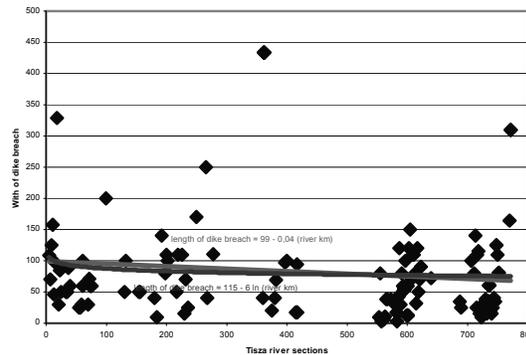
Figure 5. Length of dikefailures distributed by the rofiling of the River Tisza

Of the 329 dike failures along the Tisza in the past 150 years, breach length is known in the case of only 142 instances. Total length reaches almost 11,5 km, which brings average length to 81 meters.

Figure 5 presents the length of dike failures distributed by the profiling of the River Tisza. The length of dike breaches along the Upper Tisza is not at significant variance with downstream data, nevertheless the curve of both the linear and the exponential trend climbs slightly upwards as the river approaches the recipient Danube, but the increase is not significant. The exponential curve reflects the effect of the embouchure into the Danube, but mention must be made of the fact that the backwater effect of the Danube is longer.

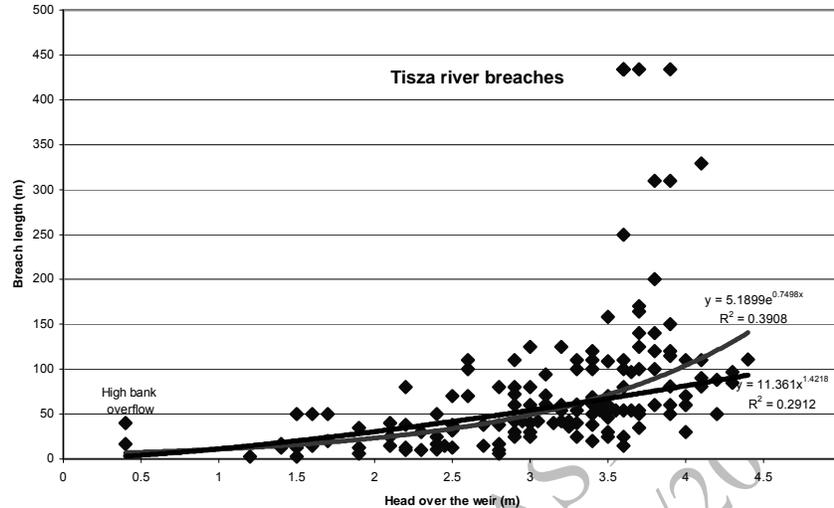
Using the methodology described above we estimated the head on crest of the overflow at the initial stage of the failure for dike breaches along the Tisza (Figure 6). These figures should be treated with caution because the accuracy of the overflow height may be at +/- 30 cm variance² with actual fact due *inter alia* to the

Figure 6. Head over the weir and the length of a dike breach

Figure 6 points out no more than the tendency of the relationship between. As overflow height increases, so does the length of the dike breach but the correlation is sloppy in terms of both the power function and the exponential function (Figure 6). That is probably due to the multitude factors that are at play. All in all, the results do not contradict the physical law that raising the height of overflow will increase the boundary shear of the water which corresponds to the increase of the opening of a dike failure. The data show that the lower the height of the dike, the less variable the width of dike breaches will be.

The two points in the left hand side of Figure 6 indicate high ground³ overflows.

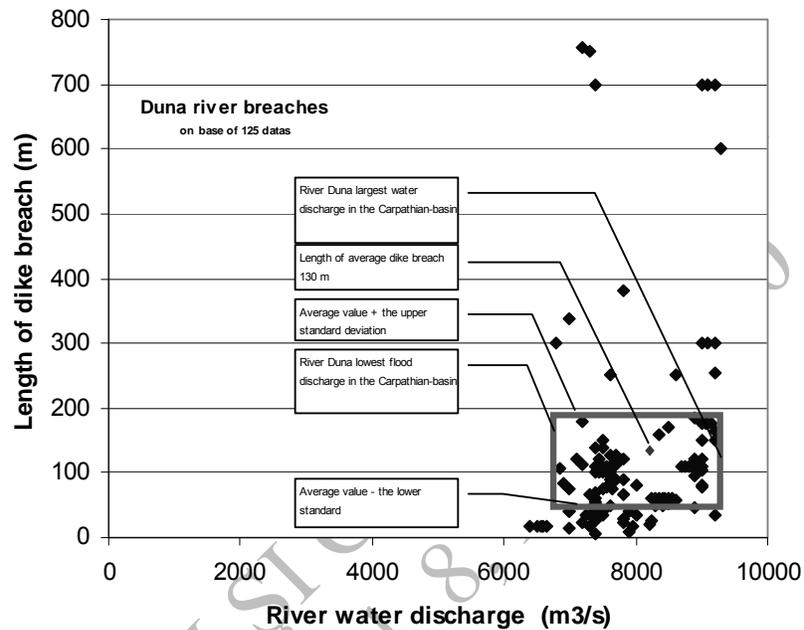
Figure 7. Length of dike breaches at river Duna

The average width of the breach of the 125 dike failures with known breach length from the total number of 397 dike failures along the Danube comes to 130 meters (Figure 7). The variation of the data taken from the left and right hand side differs, which is why the areas delineated at the top and the bottom of the output square in Figure 7 show and identical variance with the average.

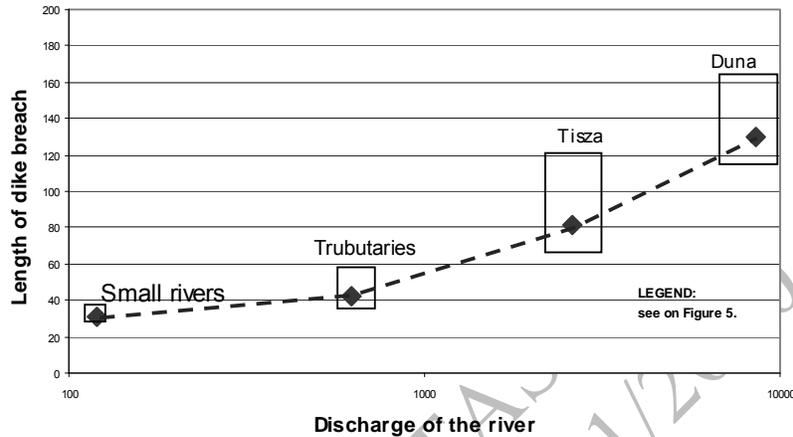
Figure 8. The average breach width for the four categories mentioned above on logarithmic scale.

Figures 8 and 9 show the average breach width for the four categories mentioned above on natural and logarithmic scale. It is clearly visible that rivers with larger discharges show the formation of larger dike breaches on average. If one can draw a conclusion from four figures, one might say that the width of a dike breach grow with grow of the river discharge.

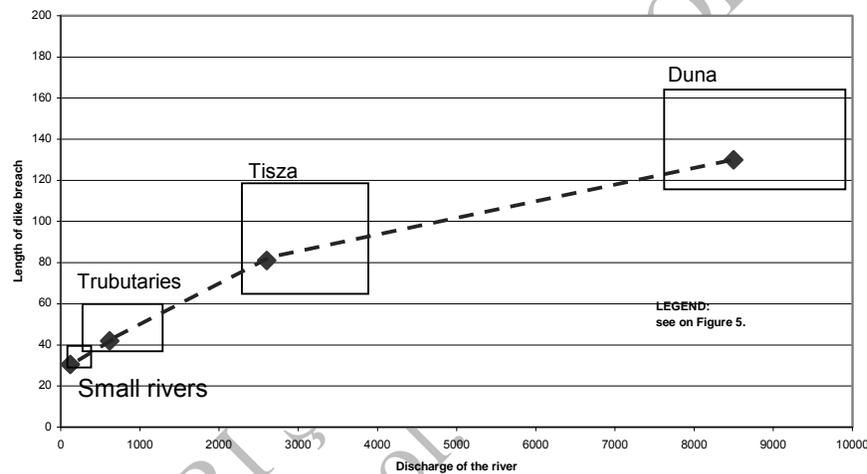
Figure 9. The average breach width for the four categories mentioned above on natural scale.

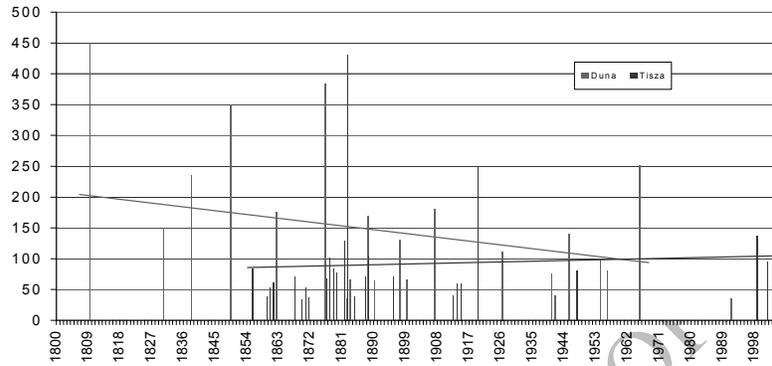
Figure 10. Length of dike breaches at Duna and Tisza rivers

The trend line plotted from annual breach length averages climbs slightly upwards in the case of the Tisza and shows a steep decline for dike failures along the Danube (Figure 10). Very small rivers and tributaries, however, demonstrate significant increases. (Figure 11)

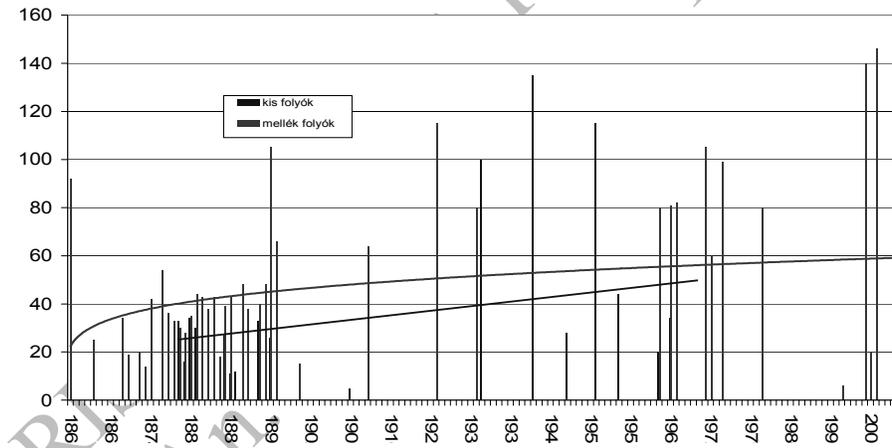
Figure 11. Length of dike breach at small rivers and tributaries
