RESERVOIR SEDIMENTATION IN THE SEBEȘ HYDROGRAPHIC BASIN

Abstract. Reservoir sedimentation in the Sebeș hydrographic basin. The hydro-energetic potential assessment of Sebeș River from the Southern Carpathians through the construction of several dams led to the appearance of Oașa, Tău, Obreja de Căpâlna and Petrești Reservoirs. The study of quantitative and qualitative characteristics of lake water was the subject of many articles. This study wants to identify the particularities of the lake sedimentation because the sedimentation rate influences the water quality and the lake's water volume, in fact the electric energy produced in the lake. For this were analysed the sedimentation sources and the indicators of the sedimentation rate, the sedimentation pace, the dynamic of sedimentation process and the characteristic volumes of each reservoir. Using the measurements made, sedimentation areas with maximum development sectors were highlighted. At the end, was analysed the influence of sedimentation process on the lake's morphometric elements.

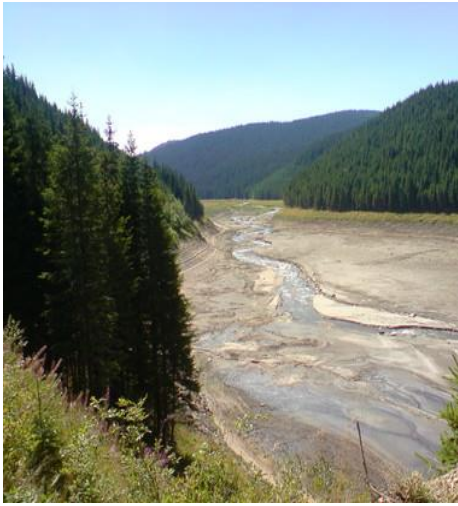
Fig. 4. Deposits and levelling at Oaşa Lake's tail

They broadly correspond to the confluences of the important tributaries in the accumulations. In the case of the Oașa accumulation, the most important areas are given by the confluences of the Frumoasa, Curpăt, Sălâne and Valea Mare rivers, the deposits having thicknesses between 15-25 cm, covering like a uniform blanket, the tail of the lake (Fig. 4).

They are formed by fine silts in which, in the area of the banks, there are large coarse elements resulting from sudden collapses or the abrasion effect of the banks.

In these deposits, the bed of the Sebeş River and its tributaries is highlighted, similar to a drainage channel during the periods of maximum emptying of the lake.

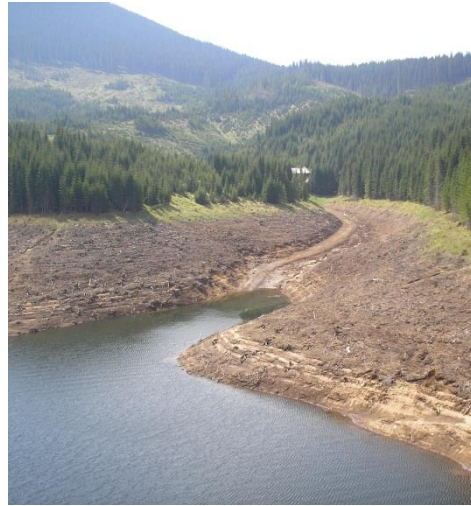
Fig. 5. Abrasion levels on Bistra Valley, Tău Reservoir

The Tău accumulation does not have discharge cones of the tributary rivers; they either converge in a cascade or have a reduced flow, therefore, a reduced hydraulic capacity to transport solid materials (Fig. 5).

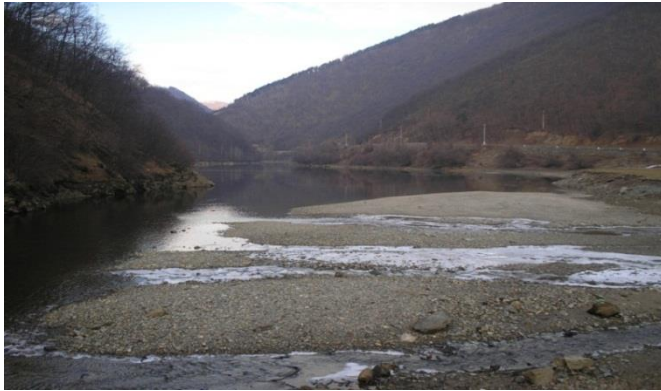
Fig. 7. Alluvium deposits at the tail of Nedeiu lake

The Nedeiu reservoir has an important area positioned in the tail of the reservoir and is due to the operation period of the ballast during construction.

The waste cone has a length of over 400 m and a surface of over 3500 m². The alluvial materials are deposited in chaotic alternation, fine silts with pebbles of various sizes. Evacuated into the lake, after washing them in advance, they were carried by the current of water coming from the CHE Șugag turbines up to more than 400 m downstream, creating cones of manure. Because of this, the length of the lake was reduced by approx. 400 m.
